Inspection Report

Test House
Deep Gap, NC 28618

Prepared for: John Homeowner

Prepared by: Aaron Messer
1147 Laurel Cir E
Deep Gap, NC 28618

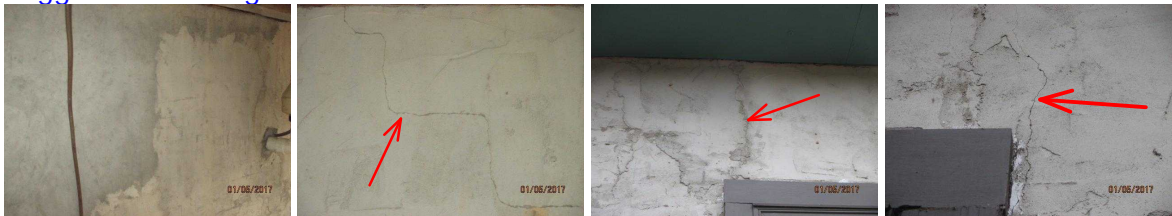
Acceptable Type: Block, Wood, Stone - Superficial cracks are noted on the West, South, and East sides. Suggest monitoring for future movement.

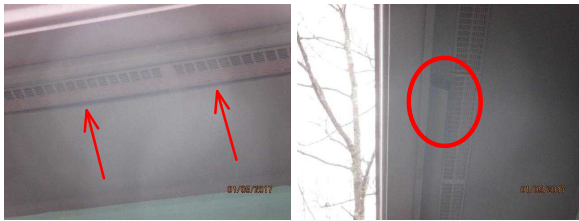
Defective Soffits: Wood - There is some loose soffit at the front/North that needs to be properly secured.

3. Soffits: Wood - There is some loose soffit at the front/North that needs to be properly secured.

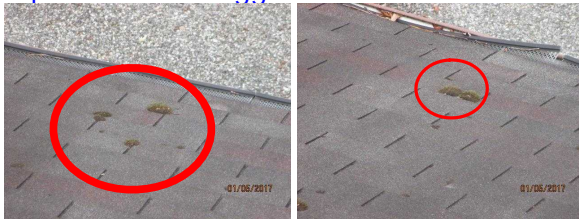
Marginal Material: Asphalt shingle - There is some moss growth on the North facing aspect of the roof that should be removed to help prevent possible leaks. No leaks were visible at this time. The roof shingles appear to be reaching the end of their normal life. Budgeting for future replacement is suggested.

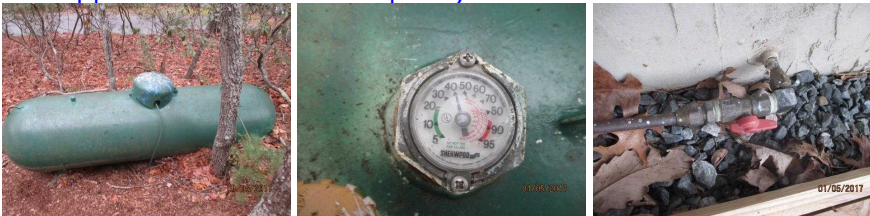
Acceptable Gas Service Lines: Copper - The propane tank is located to the right of the home on the West side and appears to be at 40% capacity.

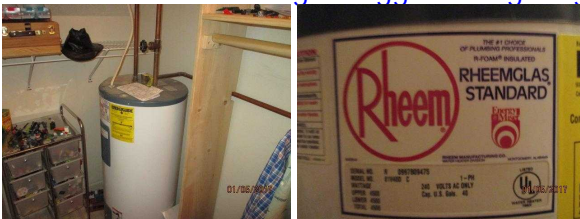
Acceptable Water Heater Operation: Functional at time of inspection - NOTE: The water heater is considered a deferred cost due to age. Suggest budgeting for future replacement.

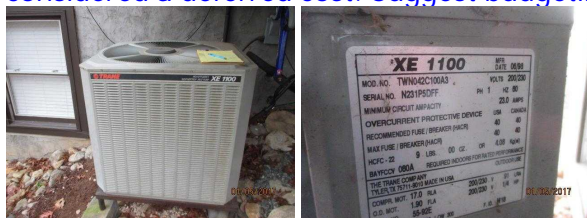
Acceptable, Marginal Exterior Unit: Mounted on elevated rack - NOTE: Due to age, the A/C condenser is considered a deferred cost. Suggest budgeting for future replacement.

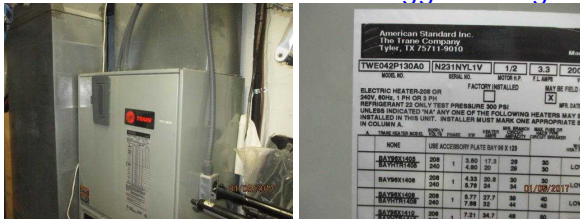
Acceptable, Marginal Heating System Operation: Appears functional - NOTE: Due to age, the heat pump is considered a deferred cost. Suggest budgeting for future replacement.

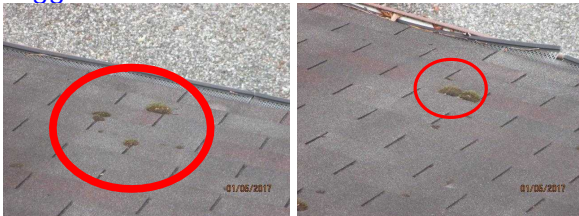
2. Main, Porch Roof Surface Material: Asphalt shingle - There is some moss growth on the North facing aspect of the roof that should be removed to help prevent possible leaks. No leaks were visible at this time. The roof shingles appear to be reaching the end of their normal life. Budgeting for future replacement is suggested.

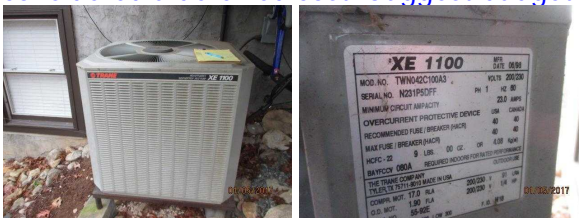
4. Heat Pump AC System Exterior Unit: Mounted on elevated rack - NOTE: Due to age, the A/C condenser is considered a deferred cost. Suggest budgeting for future replacement.

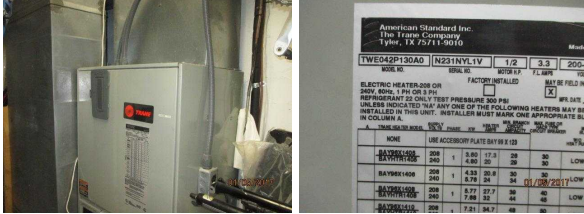
5. Basement Heating System Heating System Operation: Appears functional - NOTE: Due to age, the heat pump is considered a deferred cost. Suggest budgeting for future replacement.
